# Structural Rehabilitation of the Old Convention Pavilion in Madrid

David Izquierdo López<sup>a</sup>, Aurelio Domínguez<sup>b</sup>, Maria Oslé Aizpuru<sup>c</sup>, José Antonio Moltalvilla Fraile<sup>d</sup> y Luis Aznar<sup>e</sup>

Recibido el 1 de diciembre de 2020; aceptado el 8 de junio de 2021

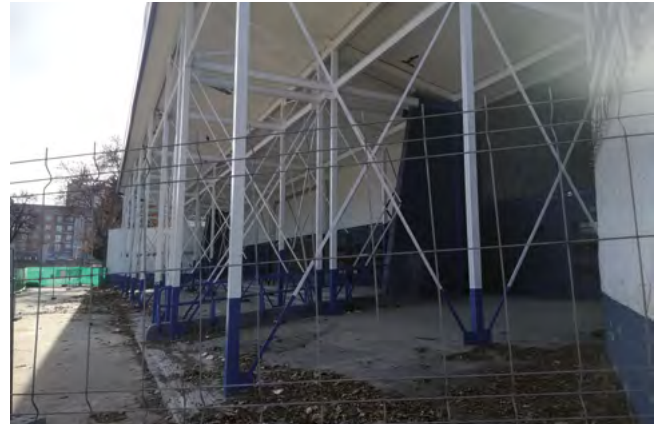
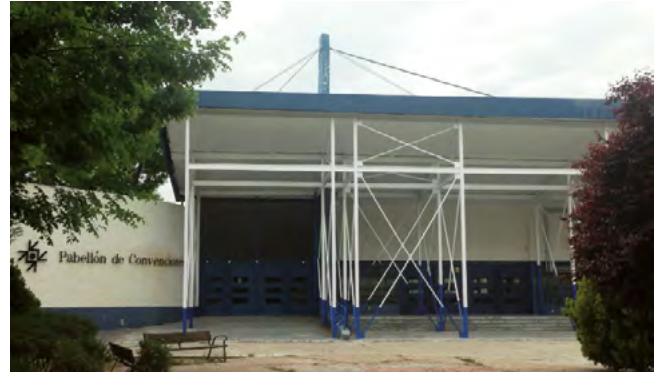
In recent years, significant increments in the main canopy deflections were observed. The problem was assessed by city technicians and, having in mind the possibility of high-alumina cement risk, the canopy was re-shored, and the building was closed. The Municipality, current structure's owner, ordered a specific structural assessment of the building and of the canopy in particular. This work was developed during 2017 in a

Figure 4. Shoring structure for the pavilion entry canopy.

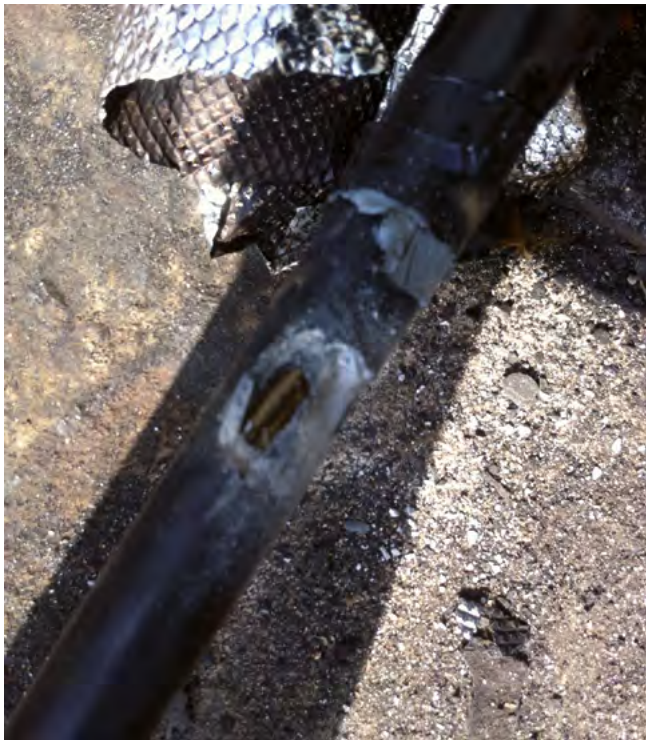
Figure 11. Internal aspect of strand and protective coating, the opening was made to assess the current state of the wires.

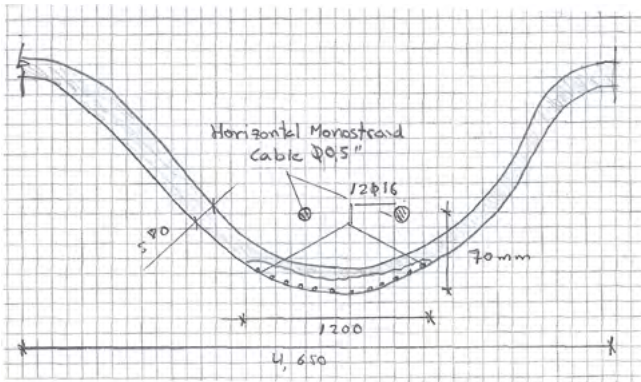
Given the reduced shell thickness, it was not easy to perform an adequate rebar survey. Only in some areas where voids exist, it was possible to identify existing rebars (figure 17). The shell cross section was verified against normal and tangential stresses, resulting in adequate safety levels, mainly

Figure 17a & b. Rebar survey from existing shell roof.

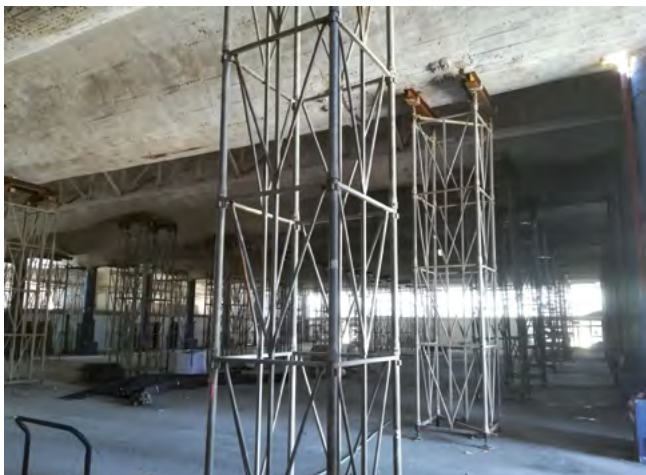
Figure 21. Temporary shoring to ground.

As a first step, the whole structure was shored to ground (figure 21). Each module was supported on 5 steel towers, one in the middle, two additional 3 m from the columns, and two more on the cantilevers at both sides. Conservatively, the calculation of maximum reaction was based on the whole shell weight acting on the shoring and the results are shown in Table 1:

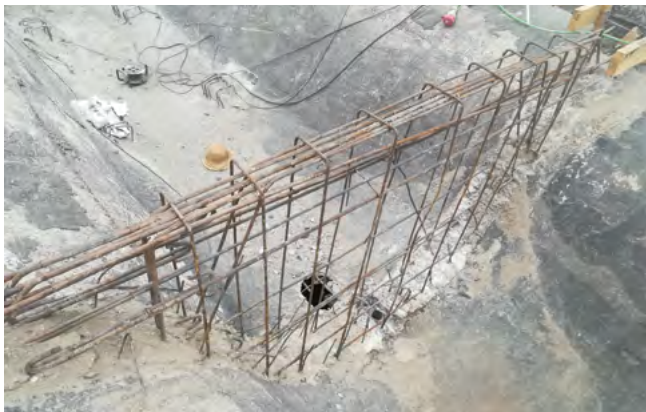
hammer (figure 24). It was noticeable that although the aluminous cement concrete was of low quality, no significant signs of rebar corrosion were detected, probably due to the good waterproofing used since years in the existing beam.

Figure 24. Supporting beam demolition and original underlying rebar configuration.

Demolition works started from the opposite side of the main entrance and works involved two consecutive modules at a time. In order to maintain the existing rebars, hydrojet demolition was suggested as a way to proceed. However, the low concrete quality allowed the contractor to perform adequately the works without any affection to the existing reinforcement (using more traditional demolition techniques, pneumatic

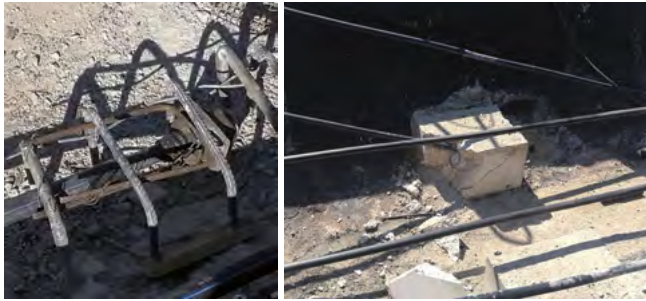
Figure 26. Existing reinforcement in the shell passive anchor block and anchorage failure.

After concreting of all modules, new stays were provided and were prestressed in the predefined order. Existing anchor blocks of inclined stays at the top of the shell, were demolished as well, keeping the existing reinforcement (figure 25). During demolition it was detected that the existing rebars presented several difficulties to be used for strand anchoring, due to the small gap between the hairpin and shell surface, which limited the stay angle (figure 26). During prestressing, the bottom horizontal stays were stressed up to 200 kN (75% of tensile strength) without any problem. However, in the case of shorter cables, the lack of existing block reinforcement, due to the aforementioned geometrical problems, produced some anchoring blocks to fail in transmitting the force to the shell (figure 27). In those cases, the stressing force was limited to the

50% of tensile strength after reassessing the structure and the block was repaired by partial demolition and rebuilt. Structural verification was performed using reduced stressing force, with adequate results. Once the stressing force was reduced, the stressing procedure performed correctly and without any relevant problem. During stressing, available load cells on the steel towers measured full unloading, verifying the adequate structural behaviour as expected.

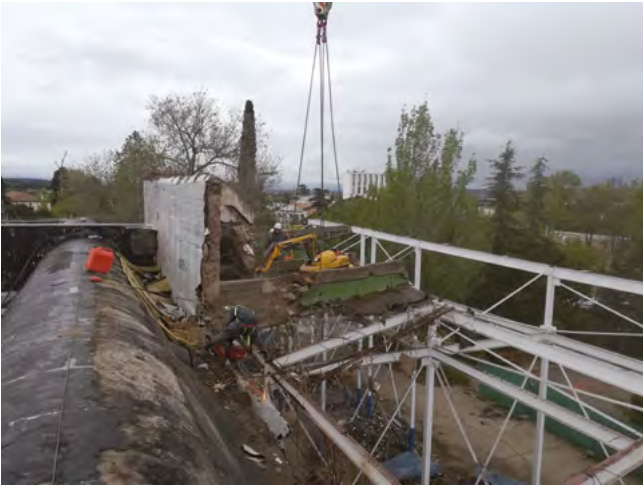
Figure 40. Existing structure demolition.

Works started by the demolition of the existing structure. After proper assessment of the existing shoring structure, the old stays were cut, and concrete structure was demolished using a remote-controlled pneumatic hammer. The existing concrete appearance is shown in figure 40, colour and texture indicate that existing concrete was made using high alumina cement as well. After the canopy demolition, piers were also demolished up to the transition level between OPC and aluminous cement, located almost at the existing ground level. All demolitions were carried out in two months.

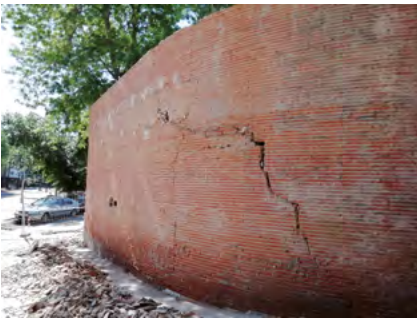
Figure 47. Masonry front wall appearance after plaster removal.

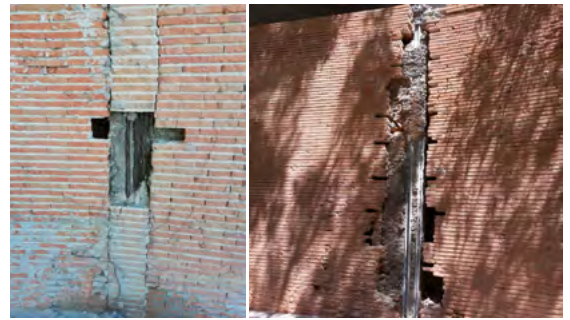
Figure 49. Embedded concrete stiffener and spalled bricks due to corrosion.

Although the main structural works were focused on the shell roof and entry canopy, rehabilitation of existing brick masonry merits some words in this article. The original state presented a coloured coated plaster, which the owner wanted to remove, restoring the original condition of these elements. After intensive sandblasting, the removal of plaster revealed the existence of severe wall cracking, caused mainly by ground settlement, lack of thermal joints and unsolved interaction between different alignments. Figures 47 and 48 show a graphical description of the masonry's real state. Some concrete stiffeners were provided throughout the wall length. Since the existing stiffeners' rebars developed corrosion, expansion products caused

not only the concrete to spall but also the covering brick pieces, (figure 49).

Masonry structural rehabilitation was implemented using embedded glass fibre rebars (figure 50). These were provided crossing the crack each 5-horizontal joints, located in the brick bed joint and glued with epoxy resin. The crack was restored using a final coating. Final appearance shows nearly no damage in brick walls, restoring their almost their initial aesthetic (figures 51 and 52).

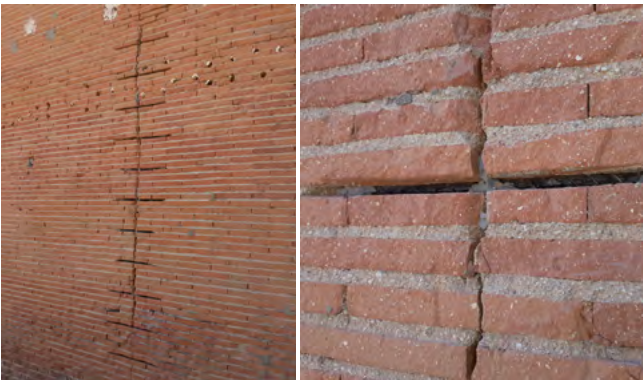
Figure 50. Glass fibre reinforcing for brick walls.
