Detection of Corrosion Risk beside Patch Repairs

M^a Carmen Andrade^a, Pedro Castro-Borges^b, Enio Pazini^c

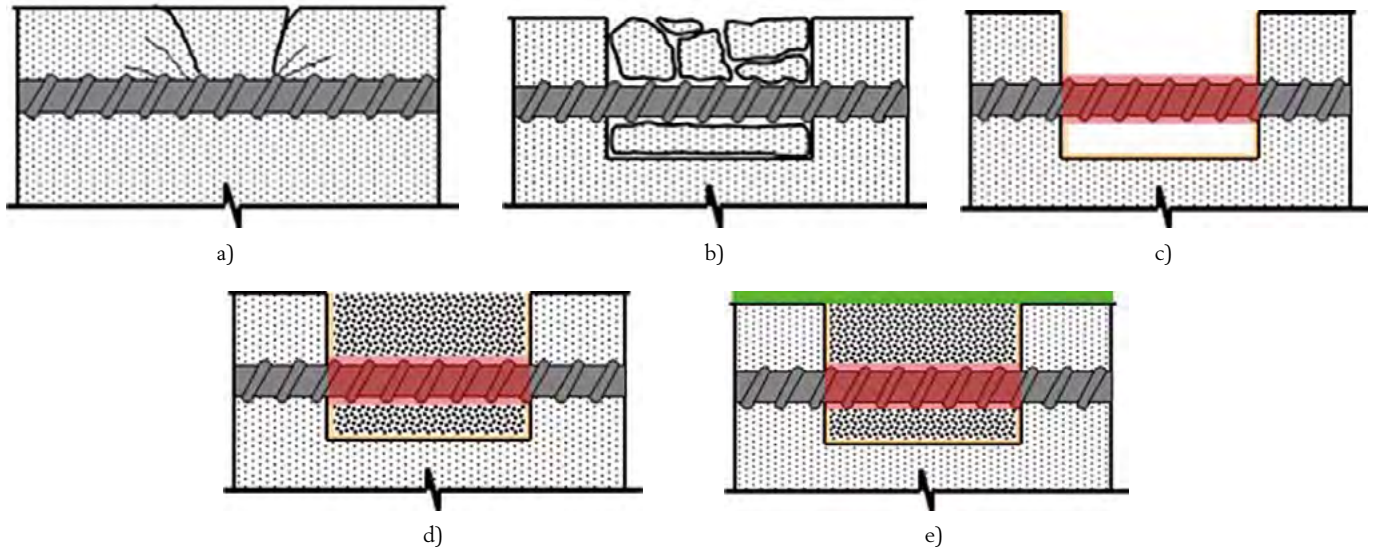
Figure 1. Stages in patch repair: a) inspection to detect damaged areas; b) removal of damaged concrete; c) reinforcement de-rusting and primer application; d) geometric restoration, and e) replacement of concrete cover.

So-called 'patch' repair, applied locally, consists in the measures listed below, the first of which is inspection to identify the areas in need of intervention (figure 1):

- a) identification of the damage and the zones to be repaired
- b) removal of the damaged concrete cover.
- c) de-rusting of the steel and (optional) application of a primer to enhance corrosion protection or strengthen the bond to the new material.
- d) (optional) application of a bonding agent between the concrete and new material and restoration of member geometry with the new material to replace the former cover.
- e) application of new cladding or paint to conceal the patch-work.

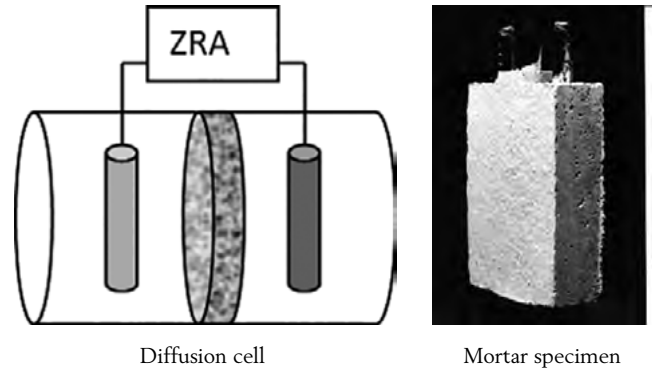
Figure 2. Left: Diffusion cell to study galvanic couples; Right: Laboratory specimen to study galvanic couples.

2. *Specimens with embedded electrodes* [15,17, 21] also provide for the use of different conditions in each electrode (figure 2 right).
3. *Beams or slabs with segmented rebar* (figure 3): Using concrete, galvanic couple testing consists in making medium-sized specimens with at least one continuous and one segmented bar like the one shown by way of example in figure 3. The wires attached to the segments bear a connection electrically insulated (taped or resin-based) from the concrete to prevent the formation of galvanic couples between copper and steel. With segmentation, the galvanic current (I_g) with a zero-resistance ammeter (ZRA) [16,19,21,24] and corrosion rate (I_{corr}) through the Linear Polarization technique can be measured separately in each segment to assess the impact of the variables studied (such as humidity, temperature and chloride content) relative to overall unsegmented behaviour.

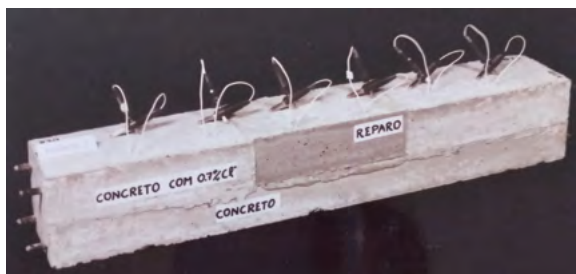
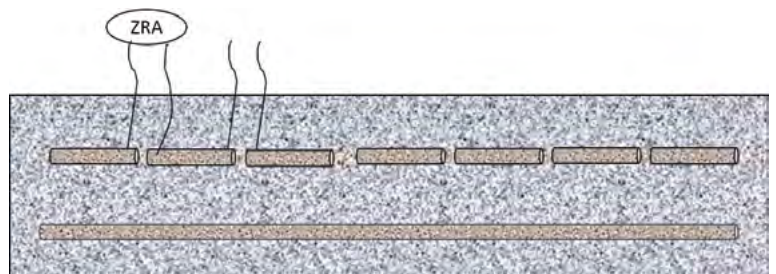
Figure 3. Segmented reinforcing bar to study galvanic current.

In all the cases ribbed bars were used. The specimen had two bars 60-cm-length placed in the bottom and two in the upper part as shown in the photo of figure 3. Those in the bottom and one in the upper zone were continuous. The other bar in the upper zone was segmented in seven parts that were elec-

trically connected. Each part of the segmented bar had 8 cm of exposure length and all of the reinforcing bars were 6 mm in diameter. They were numbered from the left of figure 1 to the right. The bottom of the beam was made with chloride-free concrete while the upper part had 0.7% of chlorides in the mixing water.

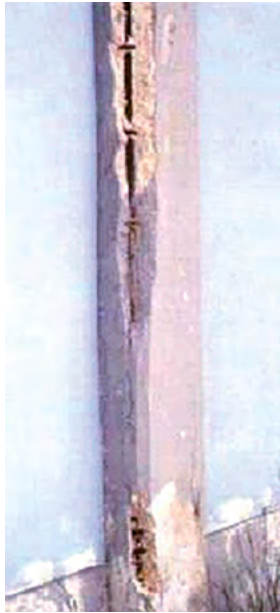
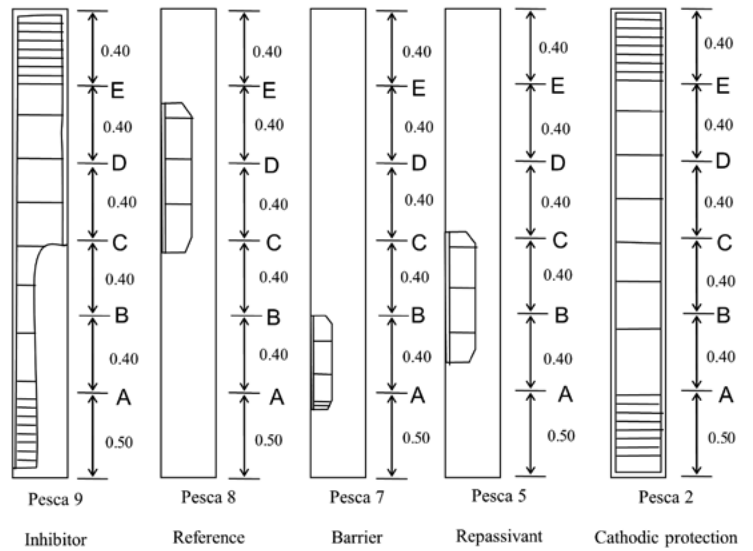
Column with corrosion stains at different heights

Patch types tested

Figure 4. Columns on a building in Mexico repaired using different systems.

- a. A building in Mexico whose columns (figure 4) exhibited corrosion at different heights on different sides. As the figure shows, the primers tested were based, in one, on a corrosion inhibitor, in the second on barrier formation and in the third zinc powder as cathode protection. Bonding agents between the new and existing concrete were likewise used.

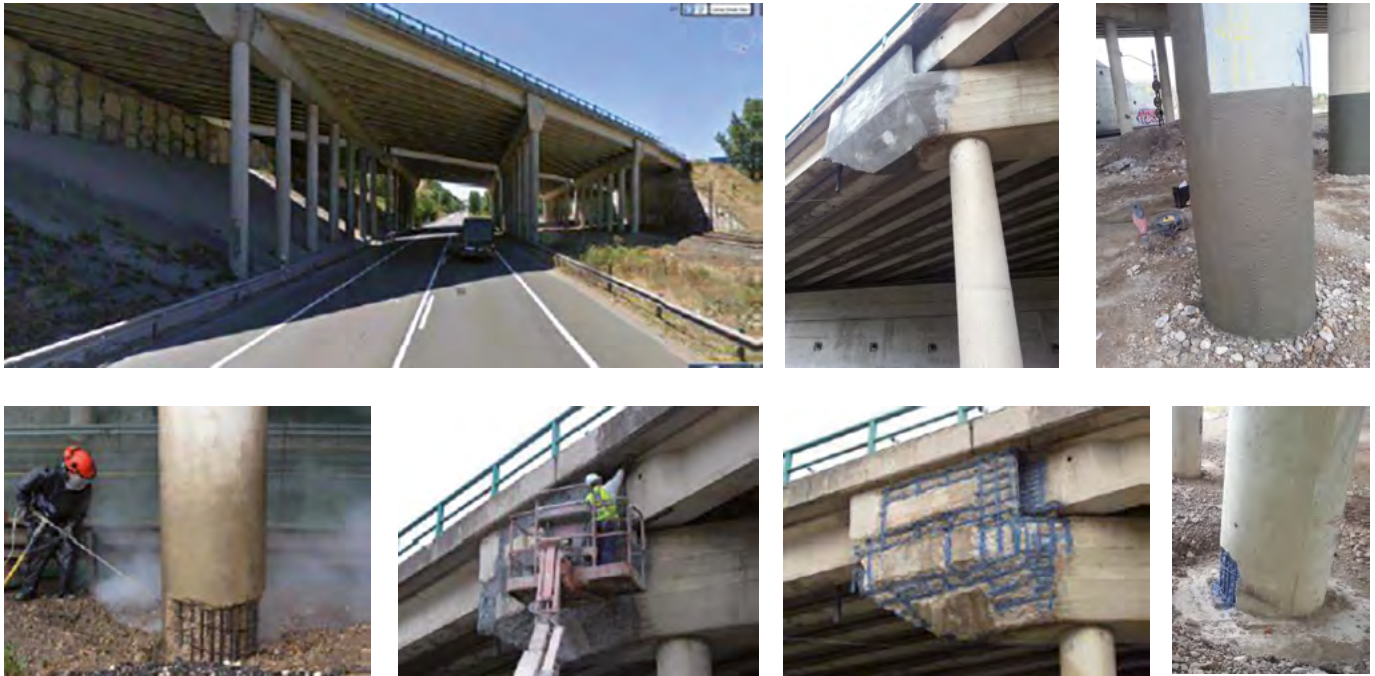
Figure 5. Viaduct on motorway AP-I (Spain) patch-repaired.³

- b. A viaduct on Spain’s motorway AP-1 patch² as part of the EXTREPHOR project [25], on which in situ chloride content measuring methods were tested and corrosion rates determined before and after repair. An overview of its split-level junction is shown in the uppermost photograph in figure 5. The middle strip of the figure depicts three stages of pier shaft and the bottom strip three of pier cap repair. The areas affected included the tops of beams and pier caps and shafts. The area repaired extended 10 cm beyond the steel corrosion damage visible when the concrete cover was removed, even where the concrete exhibited no deterioration in those adjacent areas.

The repair-protection procedure applied entailed the use of:

- a primer with a corrosion inhibitor, applied to the reinforcement before concrete regeneration with a repair mortar.
- a thixotropic repair mortar bearing organic corrosion inhibitors.
- a fluid mortar in certain areas where thixotropic mortars could not be used.
- a water vapour-permeable, elastic, anti-carbonation, water- and aggressive atmospheric agent ($\text{CO}_2 - \text{SO}_2$)-repellent acrylic resin paint.

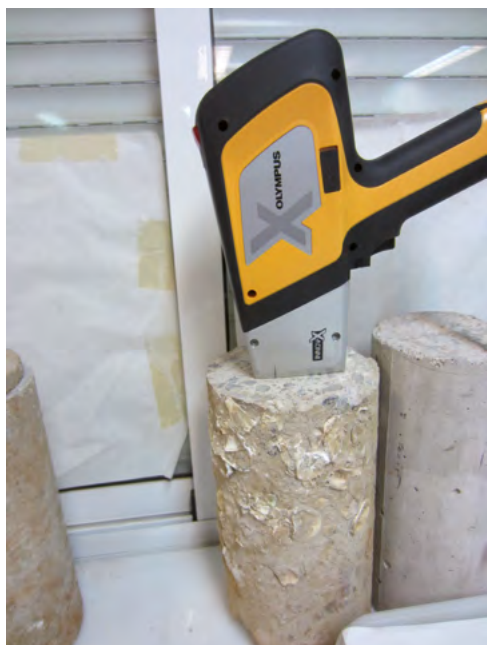
Figure 6. Handheld XRF device measuring chlorides in a concrete specimen previously exposed to natural seawater.

In light of the drawbacks to these methods for on-site use during repair operations, the literature was reviewed for possible non-destructive methods applicable to concrete. The most promising proved to be X-ray fluorescence (XRF), in use for some time in laboratories and for which handheld devices were beginning to be commercialised (figure 6). Its suitability was studied as part of the XRF-CODE project [26]. The methodology involved appeared to be simple, for the samples did not necessarily require pre-treatment, given that the X-ray beam could be focused on the concrete surface directly. Such devices are fitted with screens that display and record the readings indicative of the proportions in the sample of certain pre-selected elements.

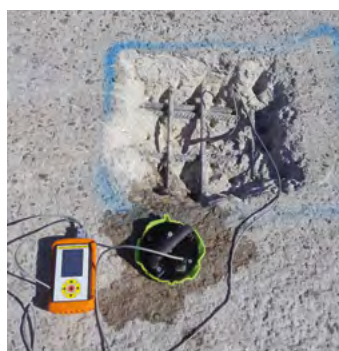
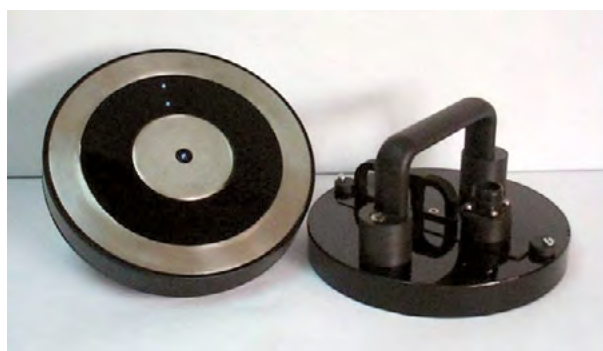
On-site corrosion rate meter

Probe with external guard ring

Figure 7. Handheld⁵ as used on site and probe with guard ring, central auxiliary electrode and control electrodes between these two.

Given that in large specimens such as beams or columns or large on-site members the area polarised is unknown, R_p must be measured with a specific corrosion rate meter. Here the instrument used throughout, a handheld device⁵, was fitted with a guard ring that confined the current to a specific area [28]. More specifically, the measuring probe for the central auxiliary electrode housed a guard ring governed by two tiny electrodes inserted between the central and guard electrodes to control the current in the latter, as shown in figure 7. The technique consisted in applying a low intensity current to the reinforcement as depicted in the figure.

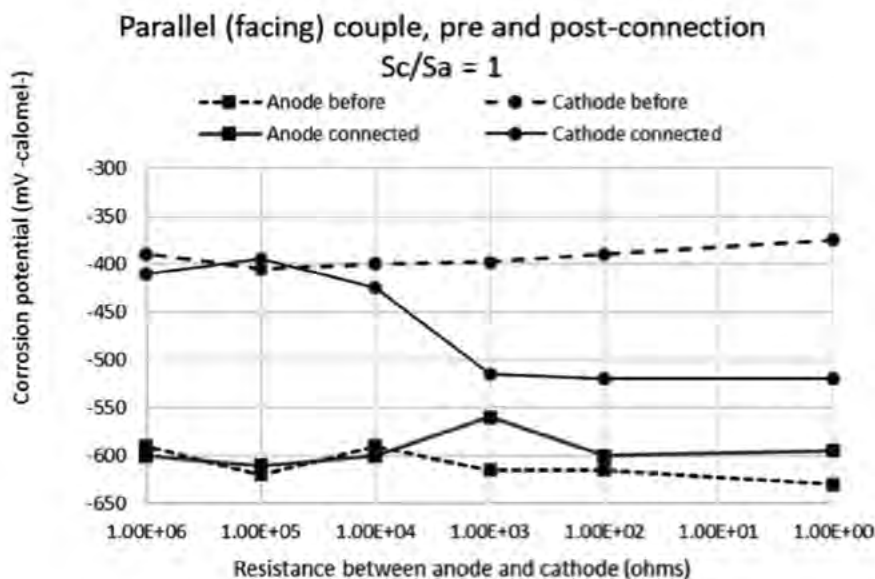
Figure 8. Effect of resistance in the circuit on anode and cathode potential before and after connection (S_c/S_a is the ratio between the surface of the cathode to the surface of the anode).

The figure shows the corrosion potentials before and after connecting the electrodes. The test was also designed to study the effect of inserting electrical resistance into the circuit to simulate different degrees of concrete saturation. Before con-

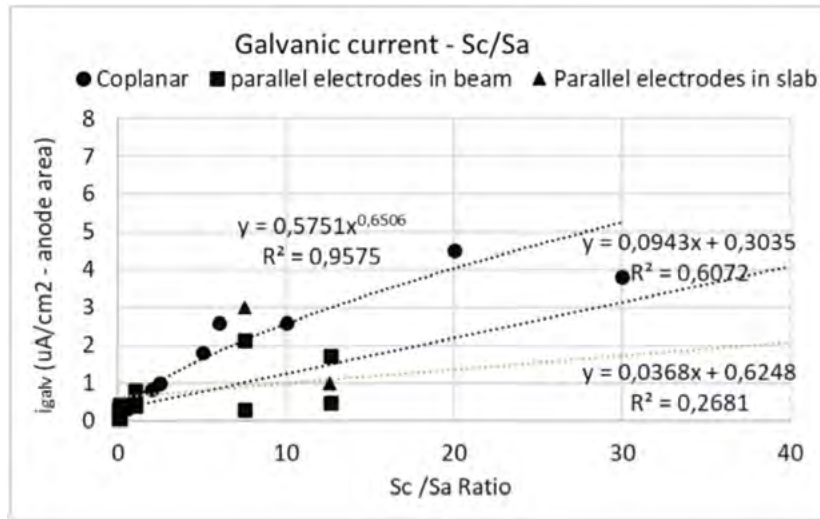
Figure 9. Galvanic current (I_{galv}) vs cathode/anode area (Sc/Sa) ratio [20,21,24].

Results for patch repair of segmented rebar were also extracted from earlier reports, in this case on concrete beams and slabs. Figure 9 shows the variation in galvanic current density (divided by anode area) with the cathode area/anode area (S_c/S_a) ratio [20,21,24]. The figure reproduces separate results for three tests conducted on members with widely differing geometries, with bars set linearly or in parallel. When the ratio rose, i.e., when the anode value declined or the cathode value rose, the galvanic current rose with it. In linear arrangements the initially exponential rise flattened at higher S_c/S_a ratios (i.e., tended to an upper limit) and where the electrodes were set in parallel, the rise was linear. The most significant finding was that the currents did not exceed an anode value of around $30 \mu\text{A}/\text{cm}^2$ and when the anode was greater than or equal to the cathode the currents were comparatively small, at around $1 \mu\text{A}/\text{cm}^2$. Of the several inferences that could be drawn from those data, the one of greatest relevance here is that (in the absence of data from other authors) inasmuch as the values concurred for three separate tests, they may very likely be liable to extrapolation to other setups. The expressions given in the figure may, then, be used for the purposes of prediction.

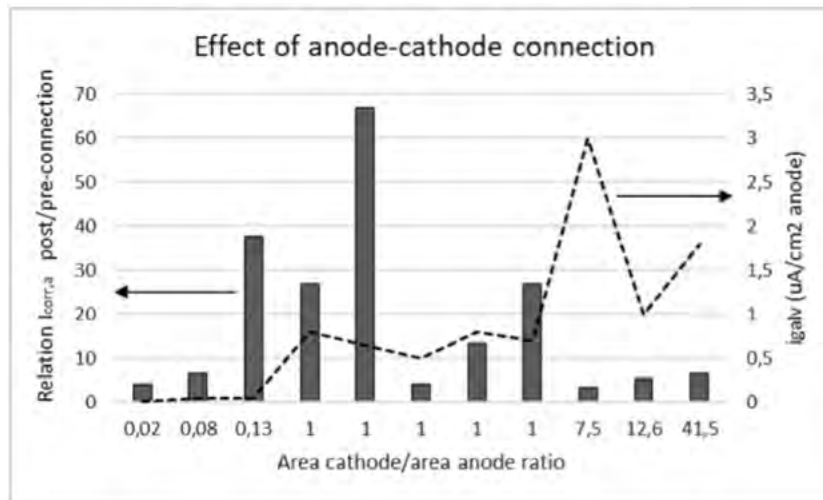
Figure 10. Variation in pre-/post-connection anode current ($I_{corr,a}$) ratio and in galvanic current (I_{galv}) with cathode area/anode area (Sc/Sa) ratio.

Two trends are depicted in figure 10: the rise in galvanic current with the S_c/S_a ratio in one of the cases analysed previously [24] and the ratio between the pre- and post-connec-

As that ratio reveals the extent of corrosion intensification when larger cathodes are connected, it can be used to assess the effect of Sc/Sa in terms of its effective value, i.e., the value of the rise in corrosion in the anodic area. Galvanic current accounts for only part of the total, as indicated by the expression:

The findings showed that corrosion was not accentuated in the anodic area when larger cathodes were connected. The findings might even be deemed odd, denoting high efficacy in area ratios of 1 and insignificant efficacy where such ratios were greater or less than 1. The explanation lies in the position of the segments connected (the test was conducted on a slab with

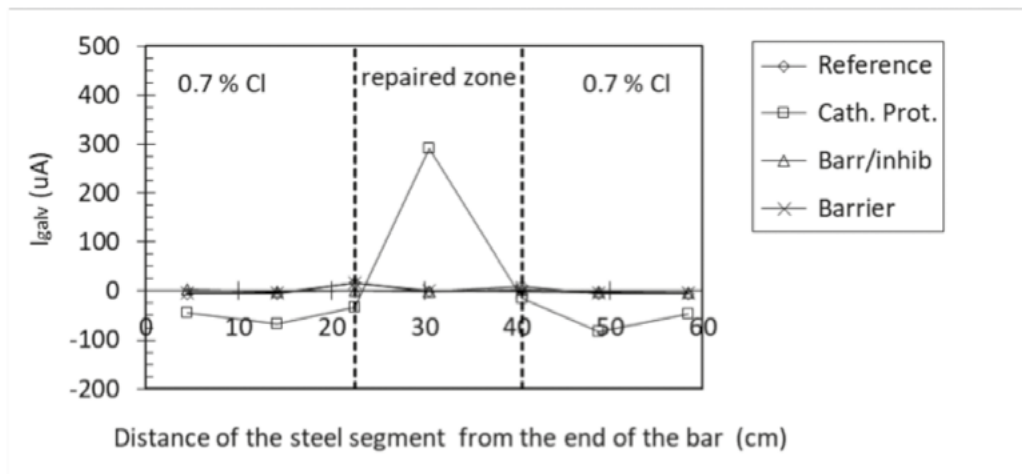
Figure 11. Total galvanic current (I_{galv}) in the seven segments of the bar positioned in the patch repair zone 3 d after repair (anodic behaviour in the repaired zone observed only for the cathodic protection system consisting in zinc powder in polymeric matrix) [19].

Other tests were conducted on prismatic specimens such as shown in figure 3 [16,19], where the central area of the segmented bar was repaired. In those trials the variations in all the electrochemical parameters with time, environmental temperature and humidity were monitored and the three types of reinforcement primers described above and plotted on the figures 11 to 14, were studied.

Total galvanic current values (not divided by any area) for the seven segments embedded near the top of the member (the three centre-most of which lay in the repaired zone) are given in figures 11, 12 and 13. Measurements were read 3 days after repair (24 d after manufacture), 103 days after repair and storage at 80% to 90% RH and 1492 days after repair, >200 days of which at over 95% RH. The environmental conditions prevailing during the test were sequenced as listed in the sub-section on materials.

The inference drawn from these findings is that when an area is repaired, the segments in the adjacent areas (in the presence of 0.7% chlorides, somewhat higher than the corrosion induction threshold) begin to corrode, albeit very slightly and for a short period of time. After a few days the currents change sign, adopting negligible values irrespective of subse-

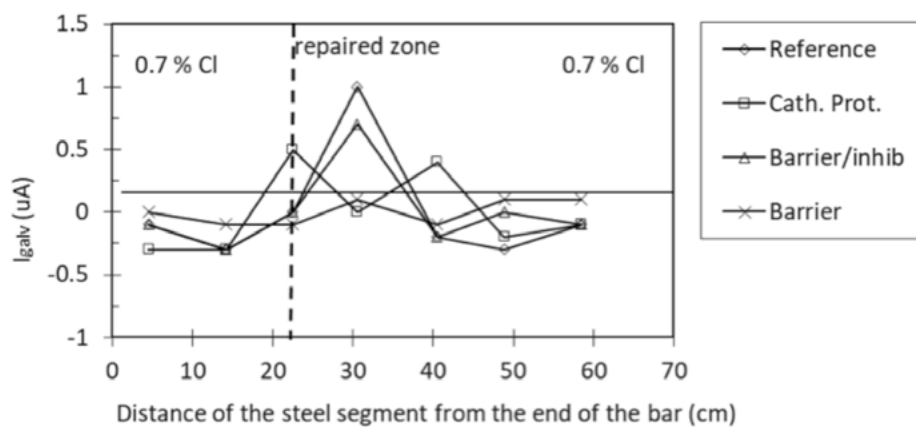
Figure 12. Total galvanic current (I_{galv}) in the seven segments of the bar with the patch repair zone 1492 days after repair (all systems observed to have very low current) [19].

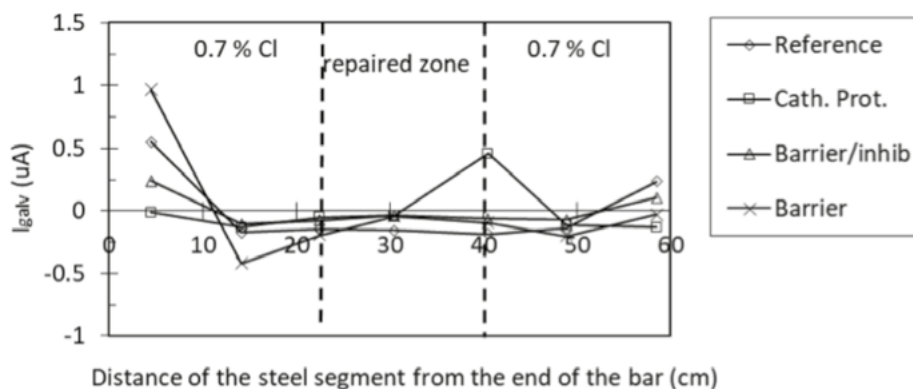
Figure 13. Total galvanic current (I_{galv}) in the seven segments of the bar with the patch repair zone 3 days after repair [all systems observed to have very low current with incipient anodic values in the outer-most segments, possibly attributable to carbonation) [19].

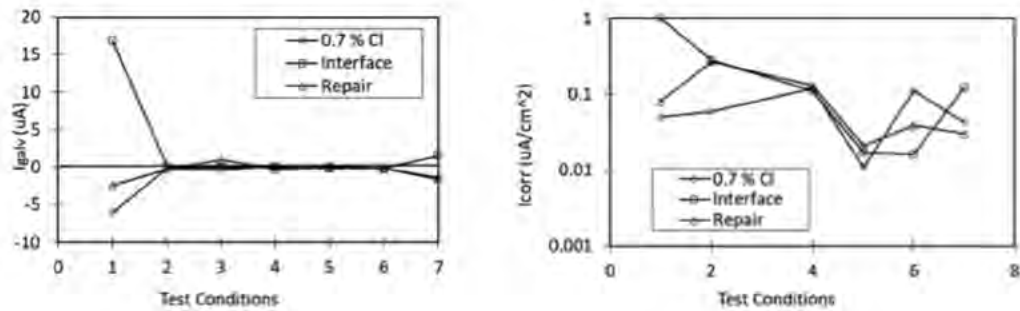
Figure 14. Variation in galvanic current over time (test conditions with time were listed in the Experimental chapter) in the repaired zone, at the repair/existing concrete interface and in the unrepaired zone (left: total galvanic current, significant only in the first few days; right: corrosion rate (< 0.1 $\mu\text{A}/\text{cm}^2$ after the first two test conditions) [19].

Figure 14, which depicts the reference prismatic specimen [19], confirms the nearly nil galvanic currents and corrosion rates in the repaired central zone, the segment at the interface with the existing concrete and the one in the existing concrete added with 0.7% chlorides. Despite the successive changes in humidity and temperature applied, the findings showed nearly nil corrosion except in the first measurement after repair.

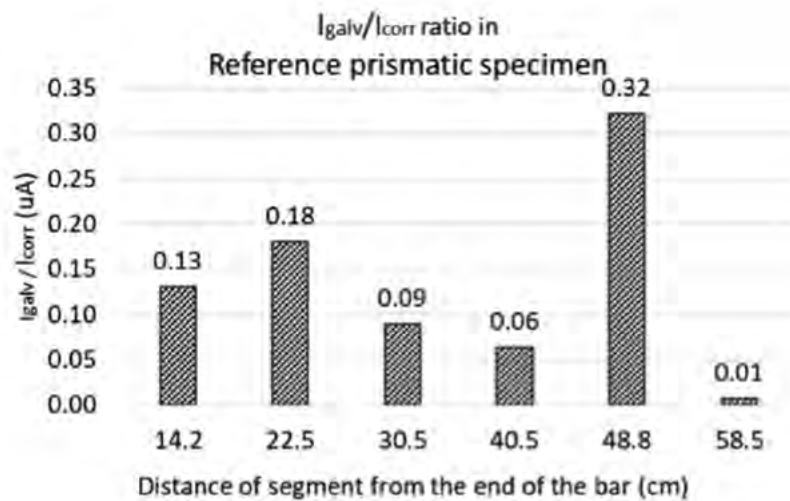
Figure 15. Variation in galvanic current with corrosion rate in the reference specimen [19].

Figure 15, in turn, graphs the relationship between galvanic current and corrosion rate in the reference specimen segments after the last, 109 days test period (around 4.5 years after casting), during which the specimen was stored at 40 °C and >95% RH. Except in one segment, the galvanic current amounted to 20% or less of the corrosion rate. All these findings denoted negligible risk of corrosion intensification, whether or not the steel was primed, although the zinc powder primer was indisputably effective for it afforded the adjacent areas extra protection.

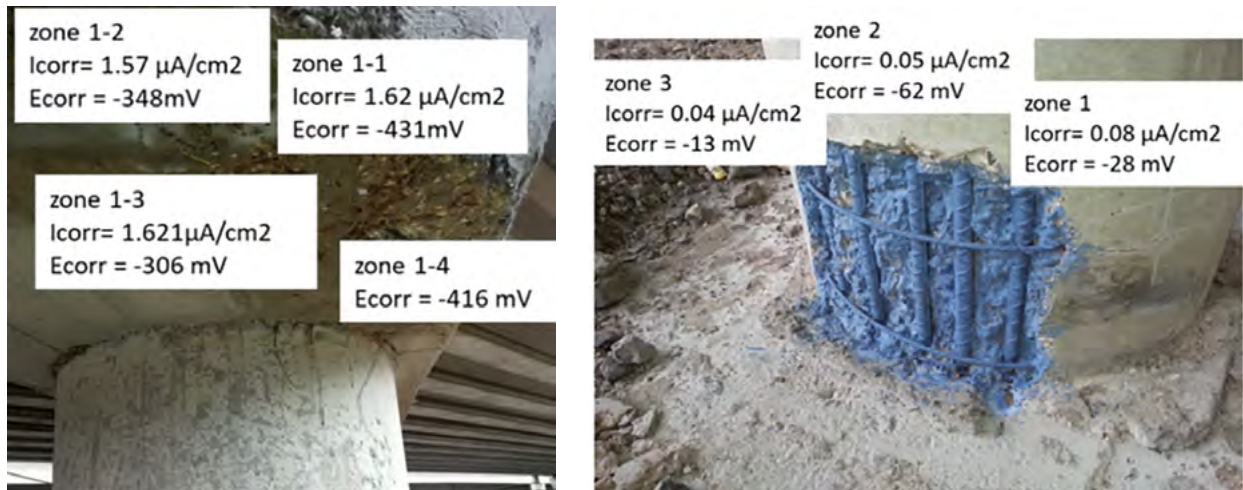
Figure 16. Left: corrosion values on the viaduct pier cap prior to repair; right: corrosion values during repair on a viaduct pier.

Figure 16 gives some of the high corrosion values measured in the pier cap on the viaduct prior to repair and the readings

around the zone on a pier under repair denoting passivity in the adjacent regions.

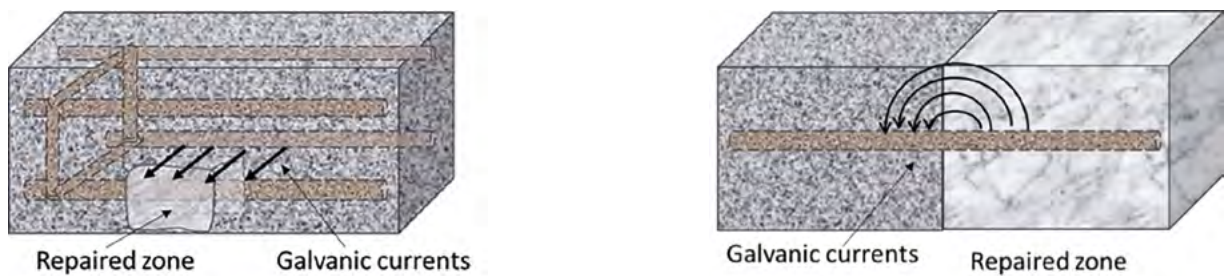
Galvanic couple on parallel bars

Galvanic couple on the same bar

As figure 17 shows, resistance in the medium varies depending on whether the metals or zones are linear or parallel, as does galvanic current distribution, which is uniform where the electrodes are parallel and tends downward with rising distance in linear layouts. The parallel couples depicted simulate situations where rebars parallel to the repaired bar are electrically connected to it across stirrups, whilst linear couples are generated on the repaired bar in areas adjacent to the repaired zone. The latter may also be found on the sides of the specimen or member where parallel couples may exist as well.

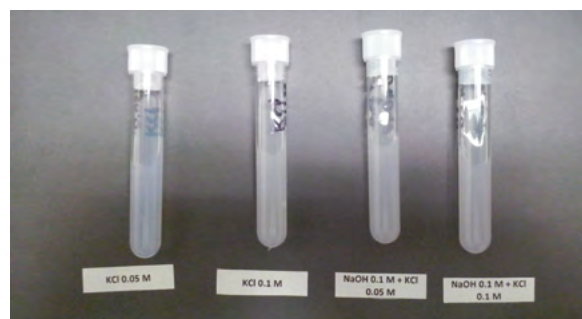
Figure 19. Turbidity test based on nitric acid and silver nitrate.

3. The turbidity method (acid medium added with silver nitrate) is somewhat simpler than the kits, for as it is qualitative only test tubes can be prepared in advance and the ground cement simply added in situ. The personnel involved must nonetheless be qualified to interpret the turbidity observed or be furnished with standard samples ([figure 19](#)) for, as inferred by the figure, drawing distinctions is not always straightforward.

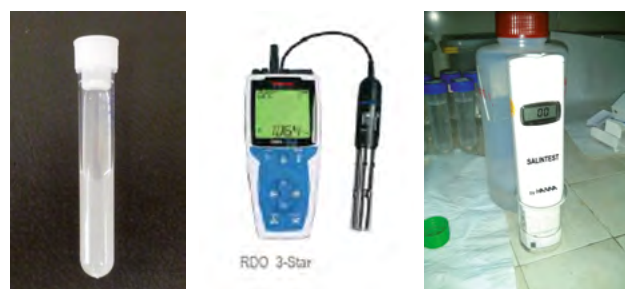
Figure 20. Selective chloride electrode test.

5. The electrode-based salinity measurement system used to monitor swimming pools (figure 20) does not measure chlorides per se, but sodium or conductivity. While it is much less expensive, then, the device is not recommended for it only measures chloride directly if it forms part of sodium chloride. It also calls for prior sample weighing and dissolution in acid or water.

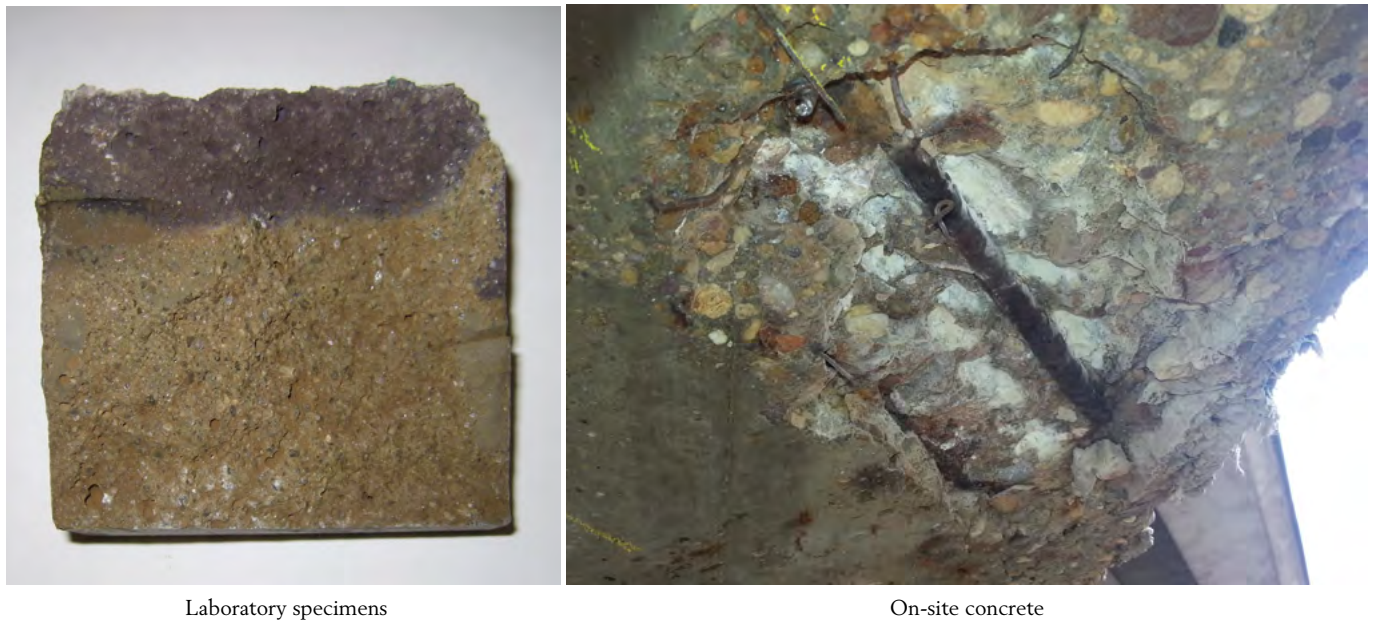
Figure 21. Colour-based silver nitrate indicator chloride test on concrete.

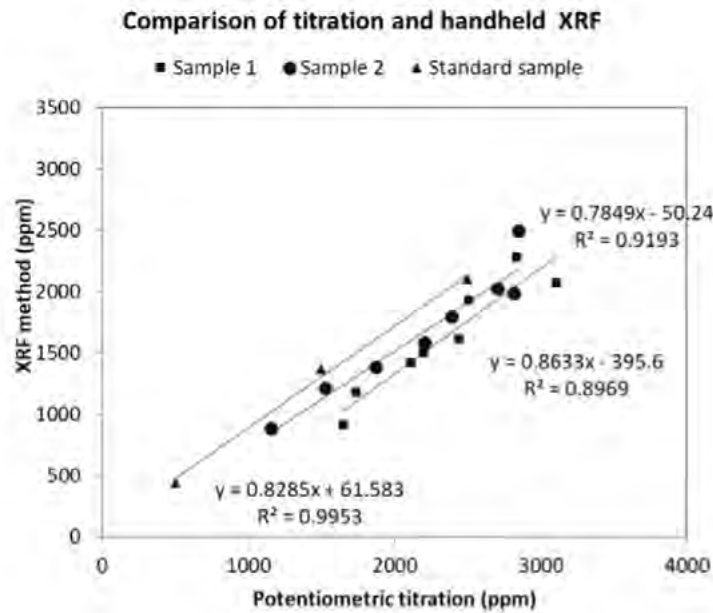
Figure 22. X-ray fluorescence/ traditional potentiometric titration procedure calibration in standard samples bearing known chloride concentrations and for two chloride profiles.

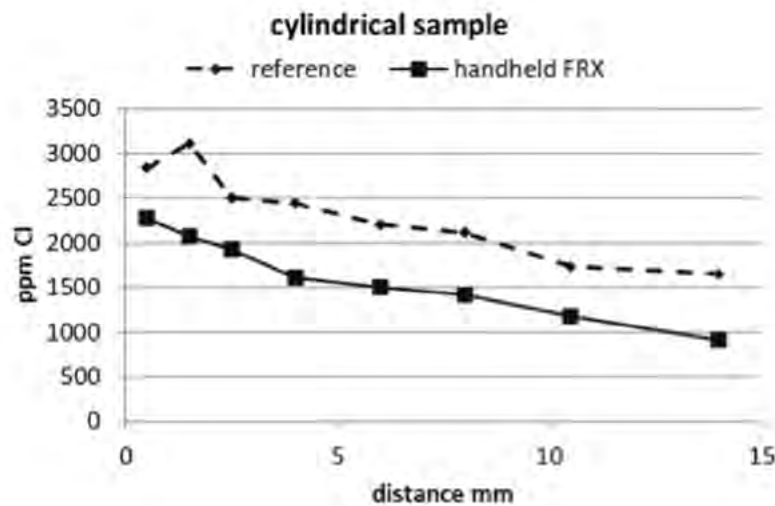
Figure 23. One of the chloride profiles used in the preceding figure, showing the difference between XRF and potentiometric values.

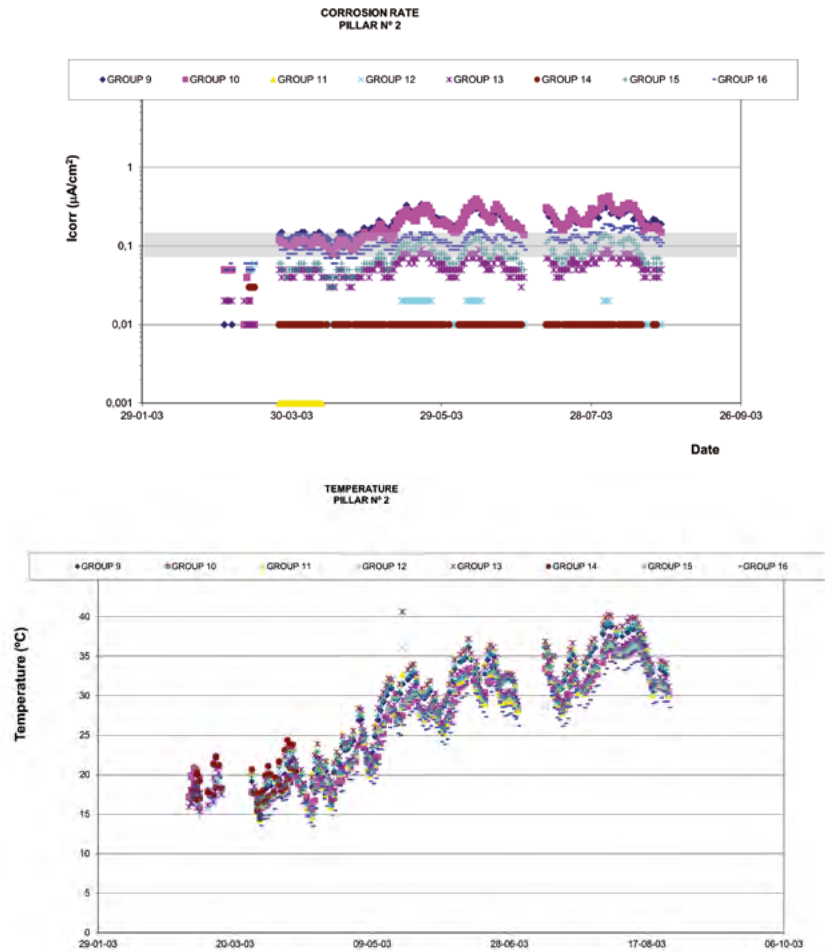
Figure 24. Up: corrosion rate values for a viaduct; and down: temperature values for the same timeframe (note the increase in I_{corr} with temperature and the similar pattern of variation of the two parameters).

is sufficiently moist if exposed to rain or seawater spray. If the concrete does not come into direct contact with water or is exposed to high temperatures possibly favouring evaporation of its water content, it may not retain sufficient moisture to support corrosion. Consequently, testing should be conducted in the winter or after abundant rainfall.
