# Structural Rehabilitation of the Old Convention Pavilion in Madrid

David Izquierdo López<sup>a</sup>, Aurelio Domínguez<sup>b</sup>, Maria Oslé Aizpuru<sup>c</sup>, José Antonio Moltalvilla Fraile<sup>d</sup> y Luis Aznar<sup>e</sup>

Recibido el 1 de diciembre de 2020; aceptado el 8 de junio de 2021

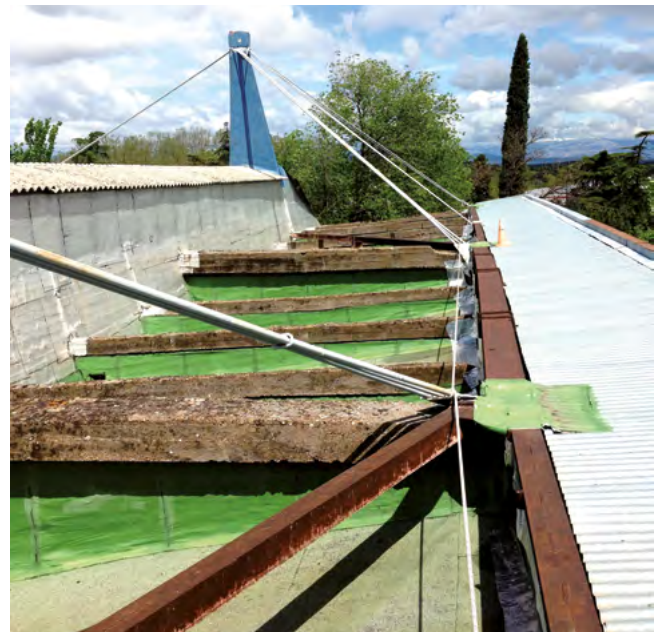
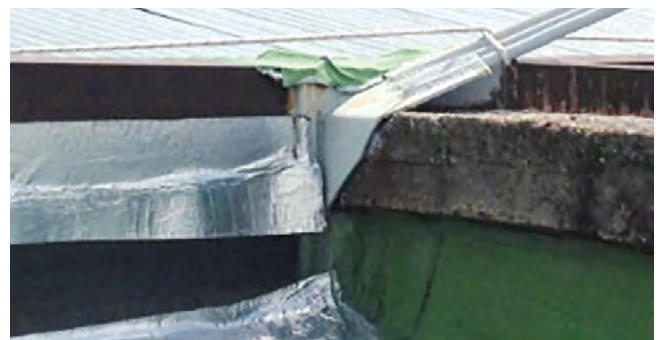
Figure 5. Canopy top face original state and stays connection detail.

The canopy structure has a total width of 44.14 m and cantilevers 7.60 m from the pier edges (figure 3). The canopy presents two large beams (walled shape) spanning the distance between piers (30 m) and covering the lateral cantilevers. The beams are 3.30 m in height and 30 cm thick. The concrete slab, which has a thickness of 120 mm, is supported by a grillage of concrete beams strengthened by boxed steel beams. At the beginning of the works, the canopy was fully shored with a steel structure (figure 4). There were no significant cracks or deflections noticed from the bottom face of the structure. Regarding the top face, the grillage is composed by successive transversal beams running from the front of the canopy to the wall beam at the back. These beams seem to be strengthened with additional steel profile sections or boxed plate steel sections (figure 5). In some cases, the added steel profiles are running from the centre of the canopy to the supporting piers. The stays are composed by

2 or 3  $\text{Ø}30$  mm of mild steel bars connected to the steel beam grillage and to the pier tops. Longitudinally there is a concrete beam, approximately 2 m parallel to the edge, which is strengthened with an additional box section steel beam, with increasing depth towards the centre. Figure 6 shows a plan view of the structural elements which compose the canopy.

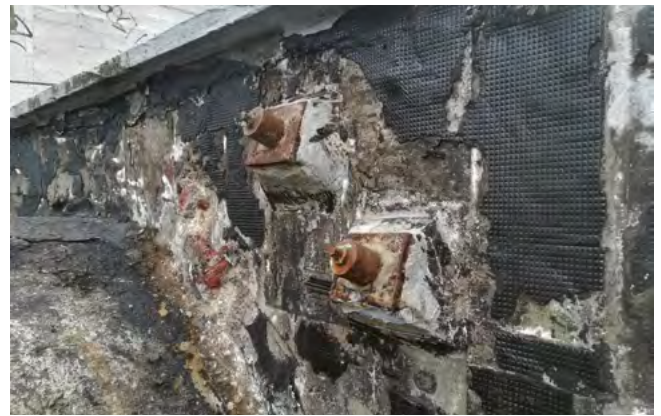
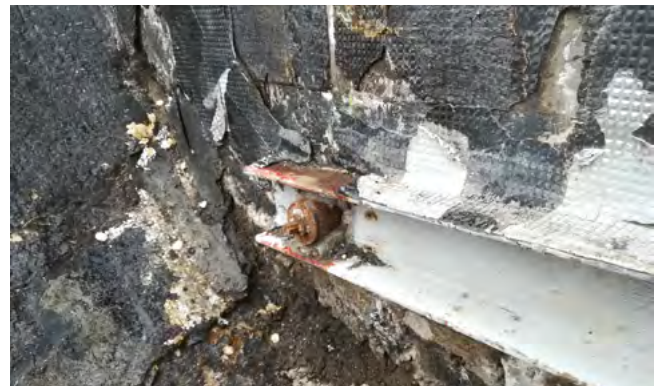
Figure 10. Strengthening cables anchorage on supporting beam.

Each module presents a total of six cable stays all of them composed by  $\text{Ø}0.5$ " monostrand tendons, anchored to the supporting beam, which are symmetrically disposed with respect to the module axis, see aerial view shown in figure 9. Some details of the end anchors are shown in figure 10. The beam is fully waterproofed and coated and no sign of water penetration was detected during the inspections. Detailed inspection of some strands showed that the plastic sleeve and the internal coating have provided sufficient protection to the steel, which shows no evidence of corrosion (figure 11). Given the technology of the cables it seems clear that they were installed during a strengthening work performed several years or decades after the initial erection.

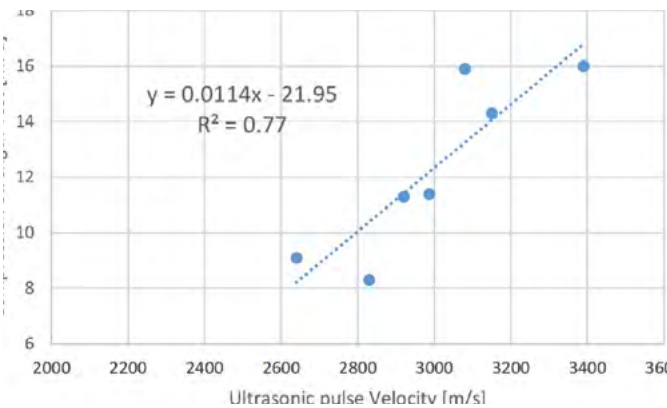
Figure 12. Estimated relationship between ultrasonic pulse velocity (m/s) and compression strength (MPa).

A total of eight tests were carried out on the aluminous cement concrete with compression strength, with varying from 19.2 to 8.3 MPa. These results show that, in those cases where the transformation is developed, a dramatic drop of concrete resistance is detected. In these areas, in situ ultrasonic pulse tests were developed in order to apply the procedure established in the EN 13791 [8] for in situ concrete strength determination. However, the ultrasonic pulse range provided in this procedure is clearly out of range for old and poor concrete quality. Thus, a simple linear correlation was adopted between measured in situ ultrasonic pulse test velocity ( $V$ ) and expected concrete compression strength (figure 12).

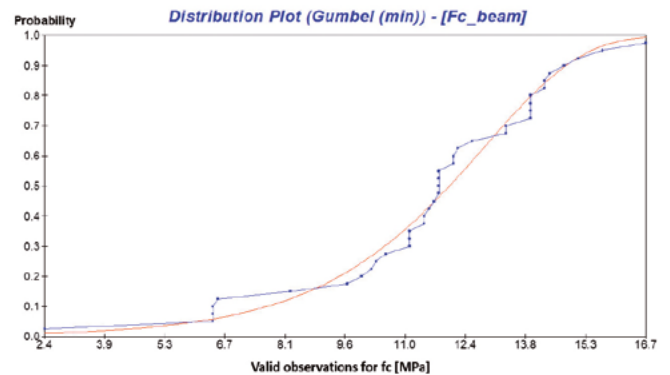
Figure 13. Statistical data and fitted distribution for estimating the characteristic value for  $f_c$ .

With an extensive mapping on the structure for pulse velocity, it was feasible to estimate the concrete compression resistance widely, ranging from a maximum of 17 MPa to a minimum of 6.5 MPa. Both values are consistent with the values obtained in core compressive strength tests performed. The statistical analysis suggests that a bimodal distribution can be fitted considering the low range as those core specimens in which the transformation is more developed whereas the upper range can be assigned to those specimens with a limited transformation. The fitted distribution is shown in figure 13, from where a characteristic value of 7.5 MPa was derived.

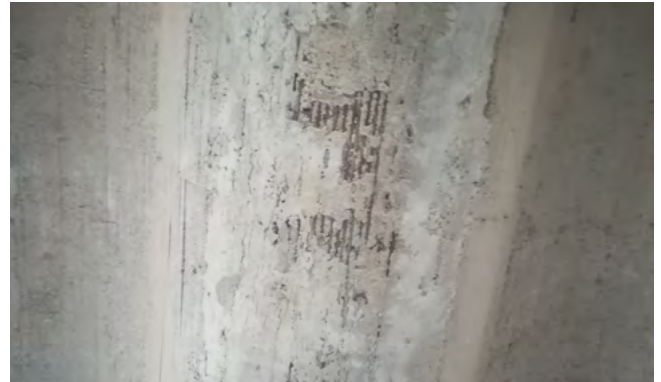
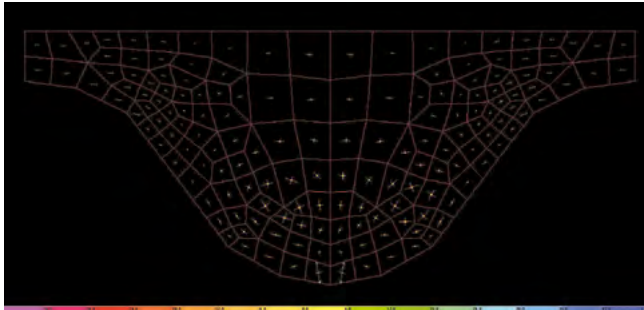
Figure 18. In-plane stress flow for the supporting beam. ELU combination.

For the supporting beam, given the geometry (4.65 m span and 2.0 m deep), a D – region analysis was performed. From the 3D FEM model, the stress flow was obtained (figure 18). This behaviour was translated into a strut-and-tie model, (figure 19), considering shear forces (conservatively) hanging from the bottom of the beam. The results of this model shows that actual compression stresses in the deep beam are low enough, even for the low concrete quality observed.

However, although the obtained in-plane stresses were low enough, out-of-plane stresses (caused by the anchoring of strengthening stays) were significantly higher than allowed. It shall be noted that mobilization of these stresses is caused by induced imposed load (since the stays seems to be stressed at low level). A limitation of maintenance live loads (due to the

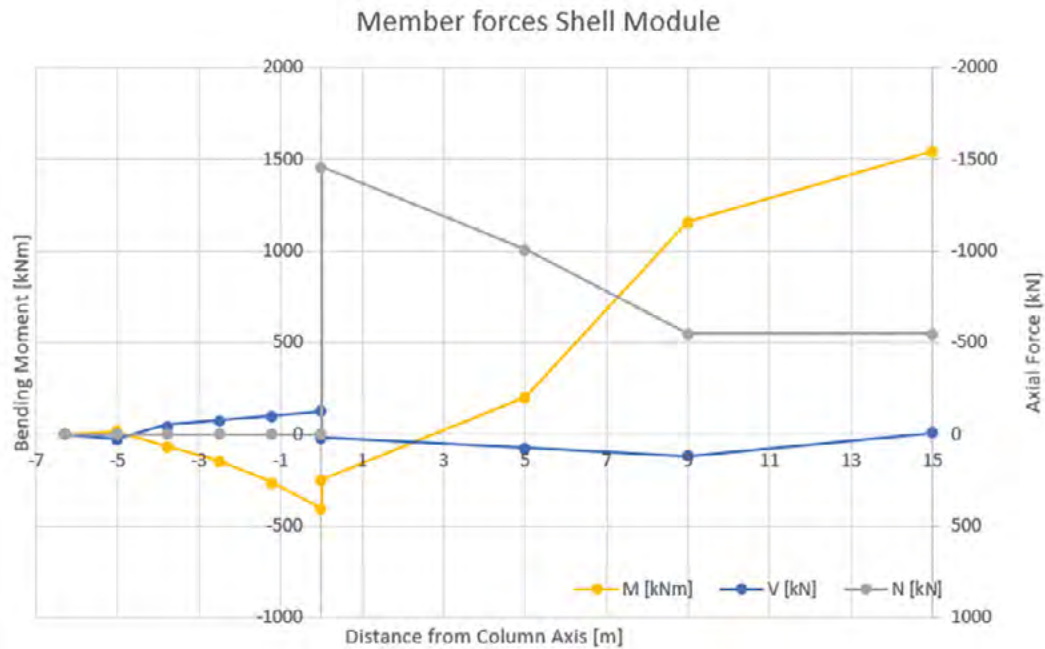
Figure 20. Comparison shell module member forces with and without (w/o) external stays.

Failure of the stays would lead into an increase of shell member forces by more than 10% for the bending moment, and would remove the beneficial axial force, which helps the concrete section withstanding actual loads (figure 20). The load increment caused by the loss of the stays would lead to failure of the shell module in bending, requiring additional reinforcement. Thus, since external strengthening stays are essential to the structural safety, and their anchorage to the supporting beam is comprised, the main structure is in severe risk because of the low quality of concrete in the beam. Given the historical classification, the intention was to keep original design as much as possible in the strengthened condition. Hence, as final conclusion, structure owner and engineering assessment suggested, given the very low quality of concrete and the unexpected evolution of actual compression resistance (by a still developing aluminous cement transformation) to rebuild the beams keeping the geometry and using a proper concrete. The following section addresses the demolition and reconstruction works for both the beam and the existing strengthening strands.

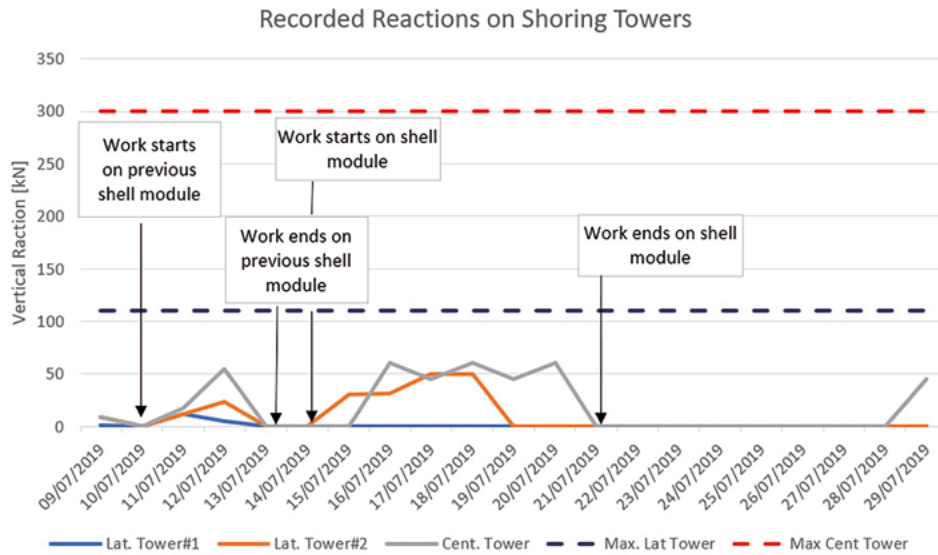
Figure 23. Registered reactions in towers vs maximum expected.

Figure 22 shows the location for towers. In order to control real reactions achieved in the towers, load cells were provided in one of the modules for types 2 and 3. The results are summarized in figure 23, where it is shown that actual reactions never reach more than 50% of the maximum expected value for the type 2 towers (located near columns) or 16% for type 3 (in the span centre). These results show the 3D structural behaviour of shells even without the rigid ending support. Since measurements were done three times throughout the day (early morning, midday and late afternoon), figure 23 shows some crests with daily variation, the measured midday reaction at centre of span was 30% less than the measured reaction at early morning or late afternoon. It is thought that the thermal gradient caused by sunlight (given the black colour of the shell surface) and the high flexibility of the structure, created an induced deformation in the shell that leads to unloading of the inner shoring towers, decreasing the values measured in the load cells, although no measurements were performed to confirm this hypothesis.

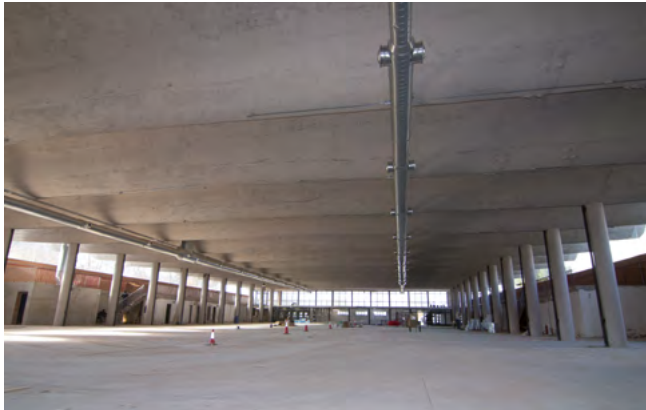
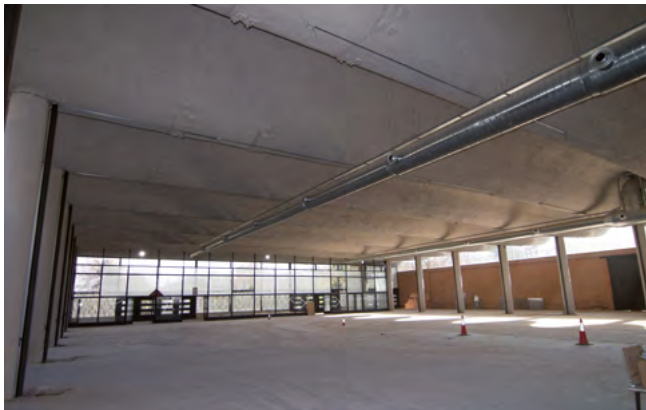
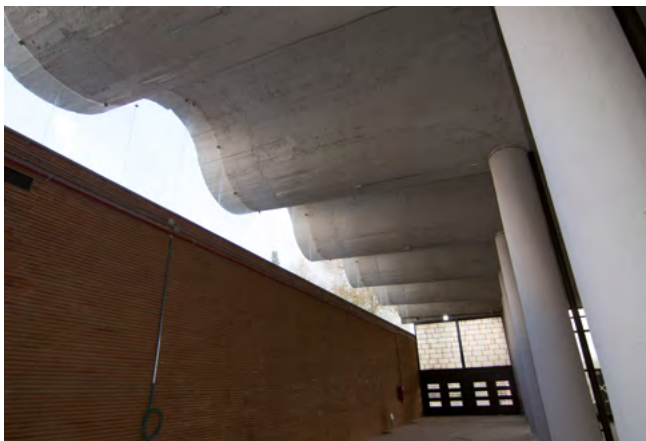
Figure 27. Final state shell roof after rehabilitation.

Once the beam reconstruction was finished, finishing works included roof waterproofing and coating, and the bottom face sandblasting and coating with an anticarbonation paint, trying to recover the original concrete appearance of the shell roof. All works were performed in only 16 weeks including waterproofing and coating. Figures 27 to 29 show some views of the final shell roof appearance after rehabilitation and beam reconstruction.

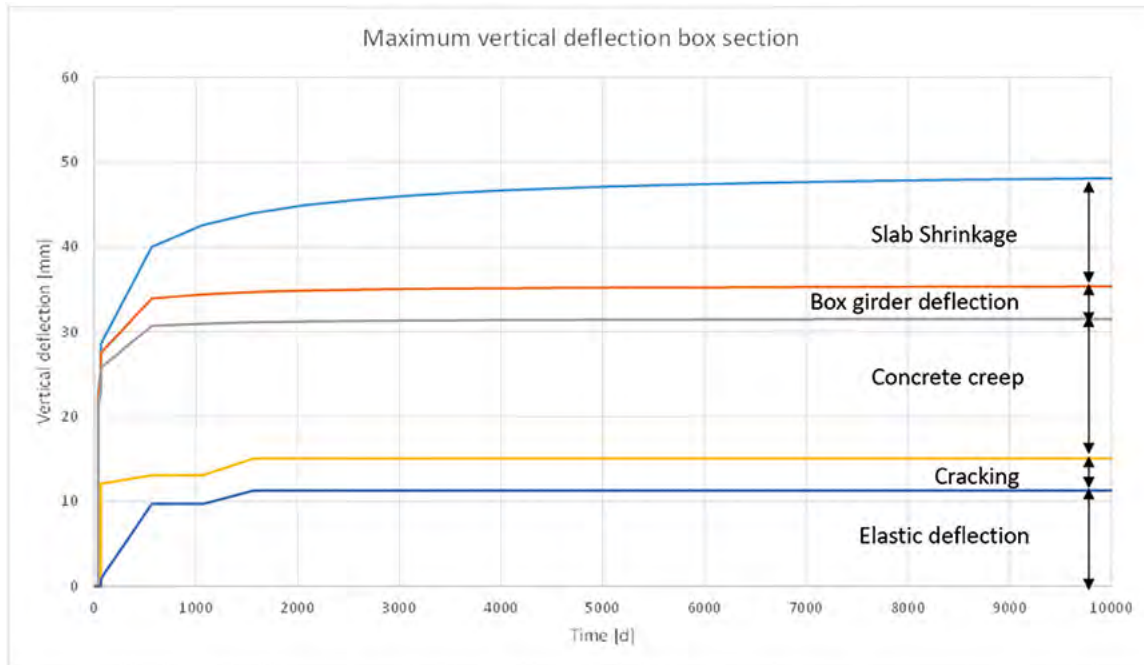
Figure 36. Effect of different actions on the calculated maximum deflection at the canopy edge for the initial solution.

ing some features: Shrinkage, Creep, Box girder deflection and stiffness reduction due to cracking. The obtained results are summarized in figure 36, together with the time evolution and show that creep and shrinkage are major contributors to the final deflection calculation (29 mm from the total 48 mm calculated), whereas other aspects such as box girder deflection or cracking are negligible (representing only 3 mm in the total cumulated deflection). Note that shrinkage plays a significant role, given the location of the concrete slab in the composite section, at bottom. Concrete shrinkage induces a positive curvature in the cantilever and increases the deflections in the canopy edge. Two lessons were derived from the analysis: first, the use of controlled shrinkage cement will lead to a relevant reduction of maximum expected deflection (- 25%) and second, the longer the shoring remains, the lower the final deflection will be.

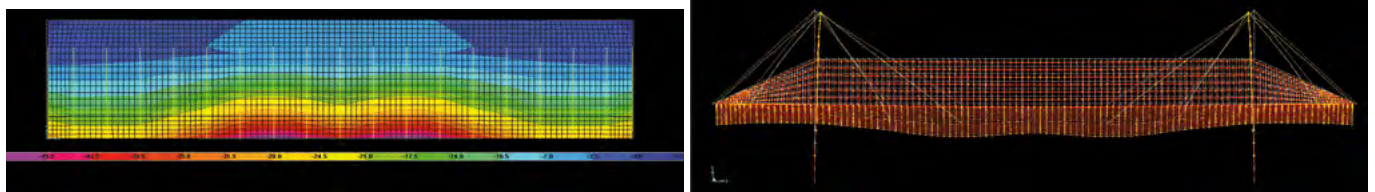
Figure 37. Final vertical deflection distribution for canopy structure for initial solution.

Some additional information was extracted from the analysis of vertical deflection in the structure (figure 37):

- The vertical deflection of the concrete box section at final time is only 5 mm, which is negligible (this was also identified in the previous analysis). Thus, the proposed girder cross section shall be considered as stiff enough for deflection control.
- The middle section of the canopy presents vertical deflections double than other sections in front of the piers. This is caused by two main reasons: lack of stiffness of the longitudinal beam which links all stay toes, and lack of stay effectiveness. This last effect is due in turn to two additional factors: lack of piers lateral stiffness, as is shown in deflection elevation, and extreme stay slope which is in the limit of  $20^\circ$ .

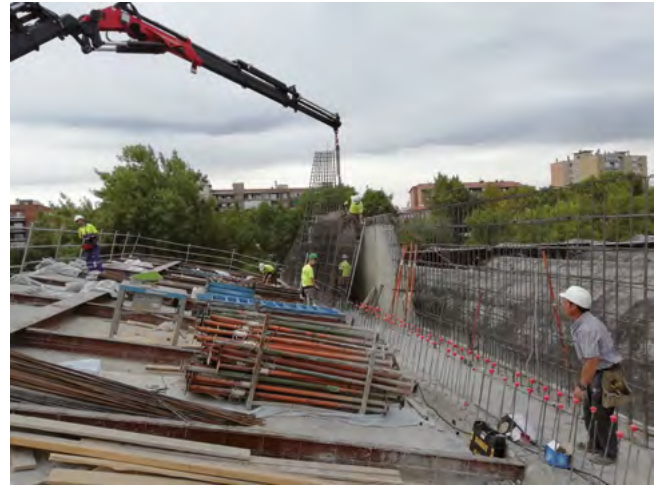
Figure 41. Box girder concreting and joint.

bers were added, but in general the structure (and its foundation) was valid for the new structure. The box concrete section was cast in three phases: bottom slab, walls and top slab. The walls were cast in turn in three additional phases providing two construction joints at span quarters (figure 41).

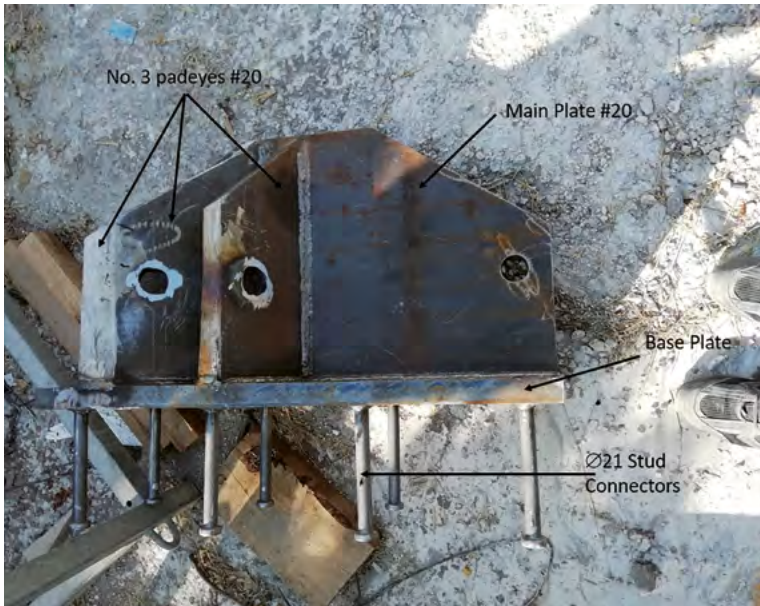
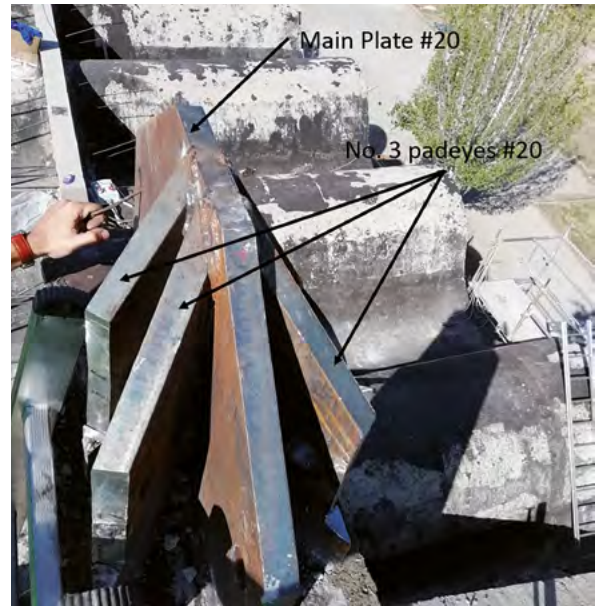
Figure 42. Connection piece details.

The connection between pier top and the stays was designed with a steel transition piece anchored to the concrete with the aid of eight  $\varnothing 21$  studs. The transition piece is composed by a baseplate, a vertical main plate and three additional padeyes, all welded together to the vertical plate (figure 42). This piece was concreted together with the top part of the pier (figure 43). The stays are anchored to the connection piece by means of a cast iron shackle and pin. Once the stays were positioned, the connection piece was covered with fairing steel plates to maintain the original rectangular shape of the pier top. Waterproofing and protective coatings were added as finalising treatment to the structure. The whole procedure was carried out in four months once the demolition phase was finalised. Figures 44 to 46 shows the final aspect of the canopy once the shoring was removed.

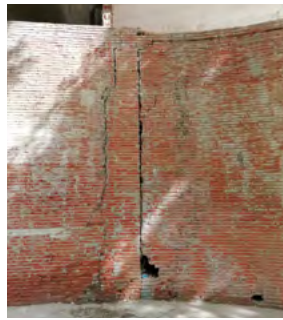
Figure 48. South masonry façade detail between different structural modules.

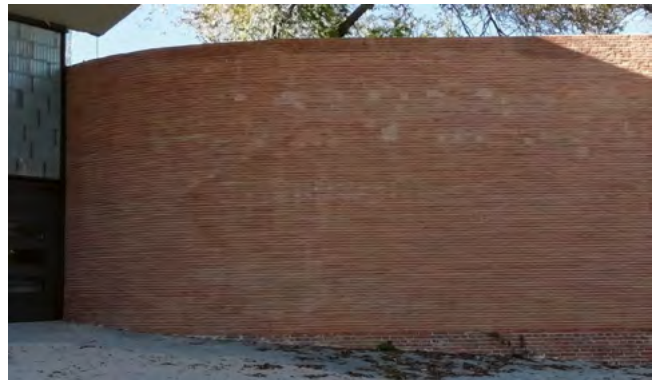
Figure 51. Final appearance of brick walls after rehabilitation.

Masonry structural rehabilitation was implemented using embedded glass fibre rebars (figure 50). These were provided crossing the crack each 5-horizontal joints, located in the brick bed joint and glued with epoxy resin. The crack was restored using a final coating. Final appearance shows nearly no damage in brick walls, restoring their almost their initial aesthetic (figures 51 and 52).

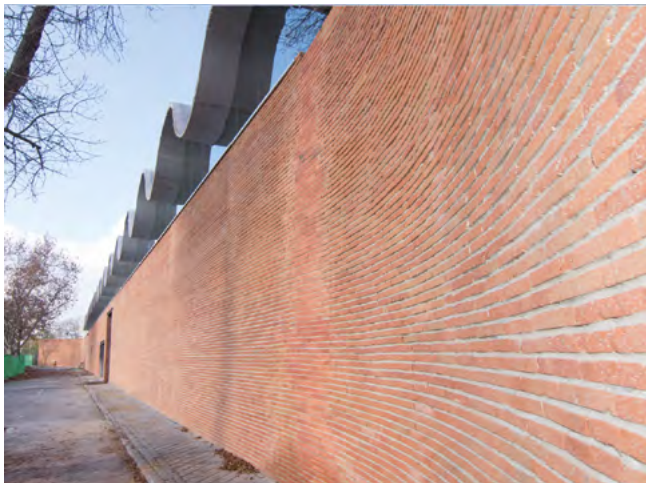
Figure 52. Final appearance of brick walls after rehabilitation.

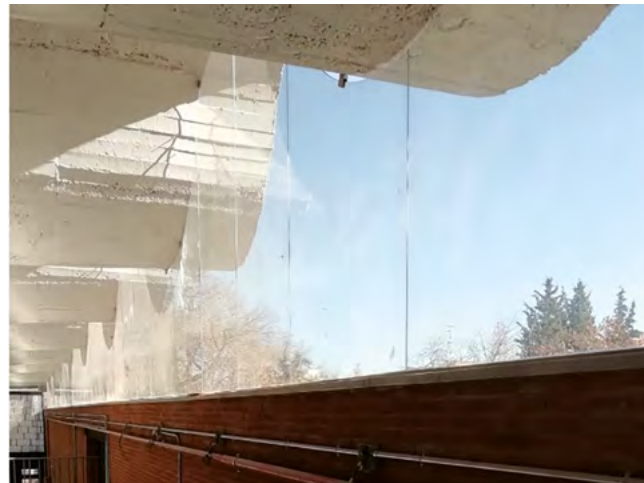
Figure 53. Glass sheets enclosure and fixation to shell roof.

Building enclosure is finished on its top, with glass sheets 10+10 mm, connected to the masonry and shell roof. Connection is detailed through a piece of stainless steel providing a gap of 10 mm on its top, allowing for deformations of the shell roof (figure 53).
